Why did *Endurance* sink?

Jukka Tuhkuri

Research Article

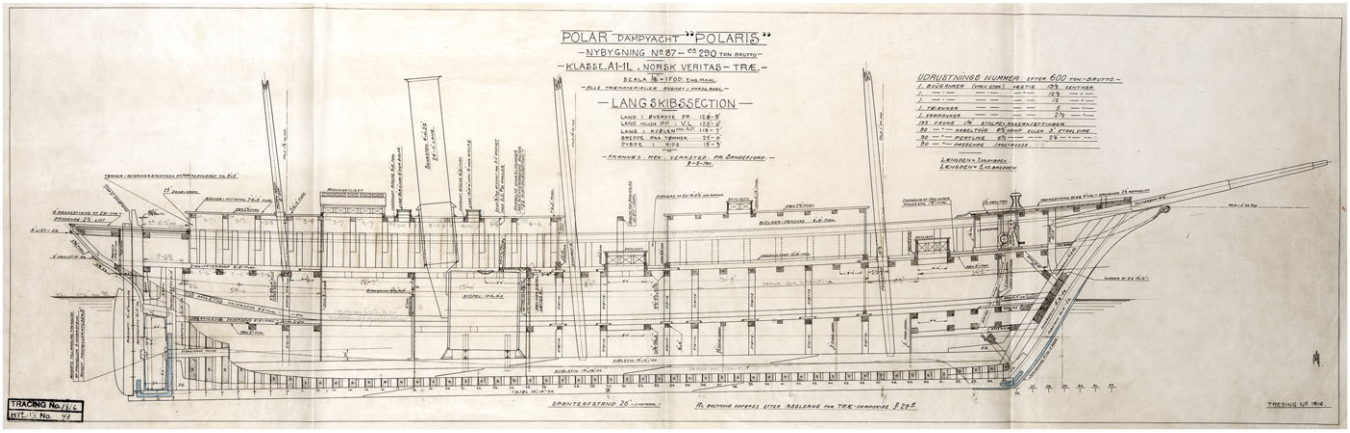
Figure 1. *Endurance*. Cross-section along the centre line, showing the hull structure (Framnæs Mekaniske Værksted, 1911). Reproduced by kind permission of the Vestfoldmuseene.

The structure of *Polaris* is shown in Figures 1–3. The ship had three decks: Lower (tween) deck, main deck and, above those, a short bridge deck. Only the main deck covered the whole ship's length. The lower deck was interrupted at the machine room to make space for the steam engine and boiler. In Figure 1, the machine room can be located by the funnel and boiler, and in Figure 3, by the large open area on the lower deck drawing. In the machine room area, only one deck beam spanned the whole breadth of the ship, and five deck beams were discontinuous. The machine room area was, therefore, a weak part of the ship.

Table 1 gives the length of the machine room for the ships studied. At 8.4 m, 22% of the ship's length, the machine room of *Endurance* is the longest of all the early Antarctic ships, both in metres and in percentage of the ship length. Figures 1 and 3 show

the structure of *Endurance* in the machine room area. In addition to the missing tween deck, the main deck has only one continuous deck beam for the whole 8.4 m machine room length. In *Fram* and *Gauss*, the machine room problem is avoided by squeezing the engine and boiler between the decks, allowing the tween decks to extend the whole ship length.

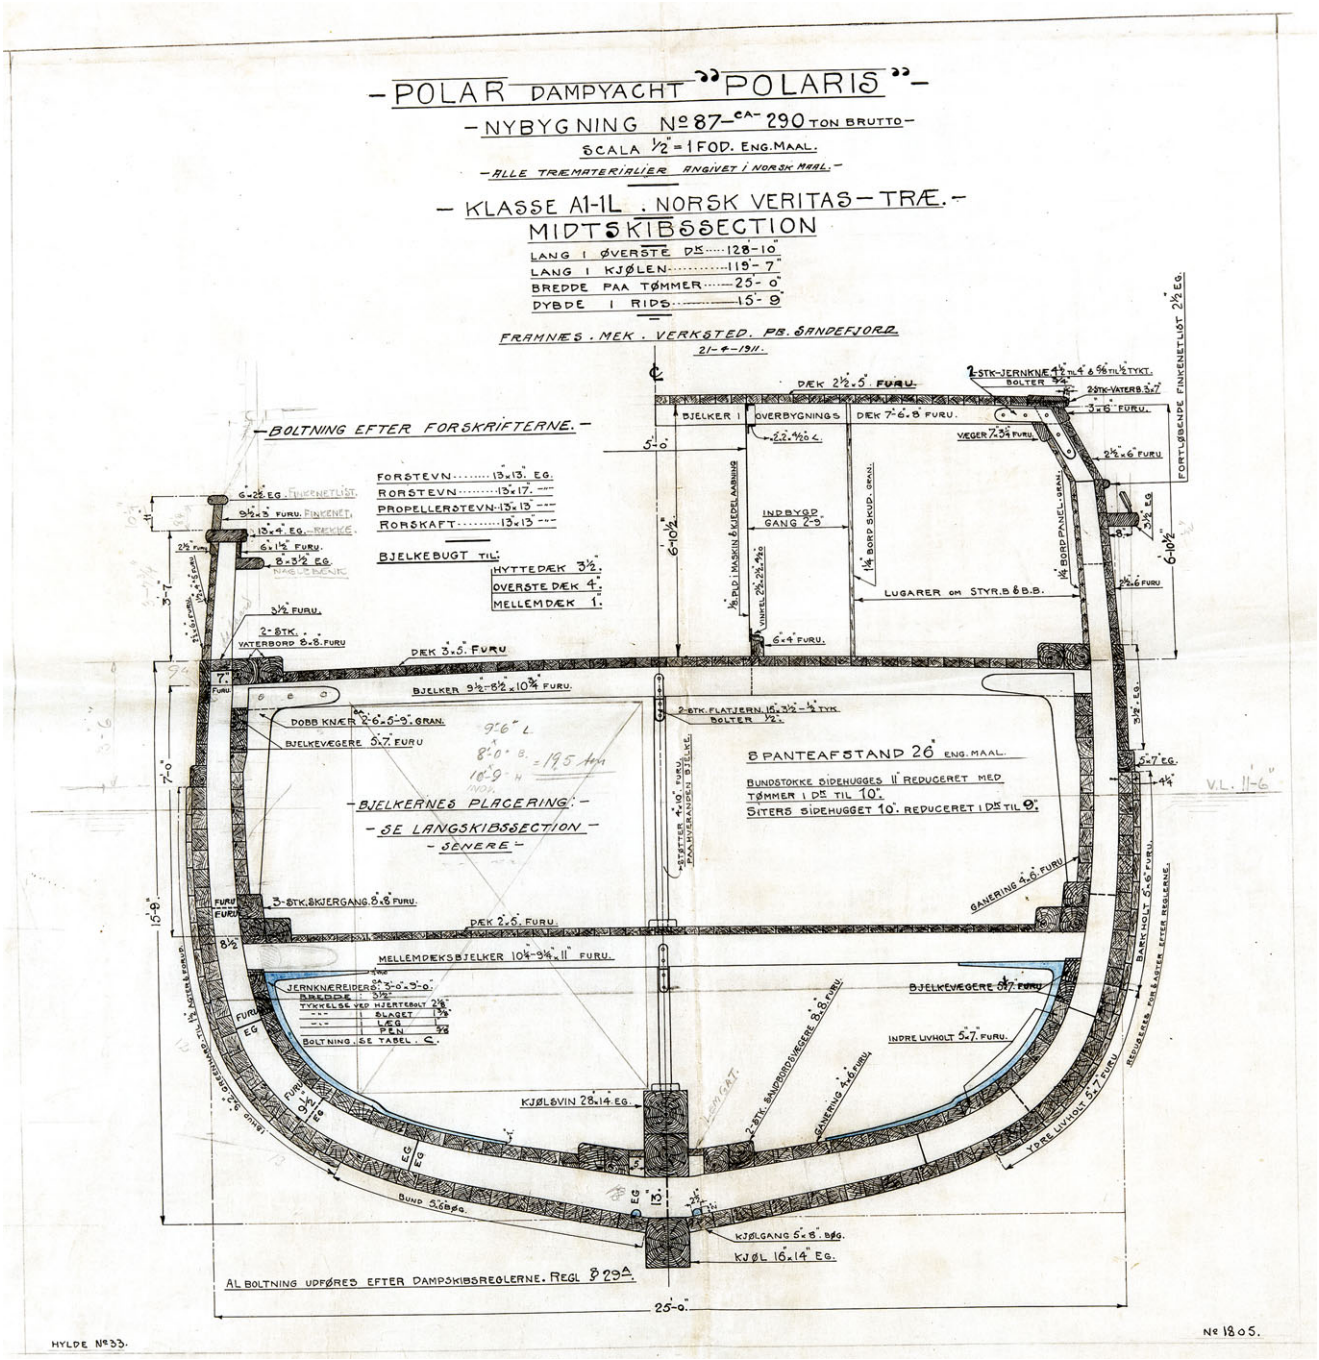
The keel was made of oak, four members on top of each other, making a total height of almost 1.5 m (Fig. 2). About 300 mm of the keel was below the hull planking. Frames were oak near the bottom and pine higher up. Planking was pine, sheathed with greenheart. Deck beams were also made of pine, and the connections of beams and frames were strengthened with knees; made of spruce for the main deck and of iron for the lower deck. The bow was strengthened with an iron rail and iron plates.

Figure 2. Midship cross-section of *Endurance* (Framnæs Mekaniske Værksted, 1911). Reproduced by kind permission of the Vestfoldmuseene.

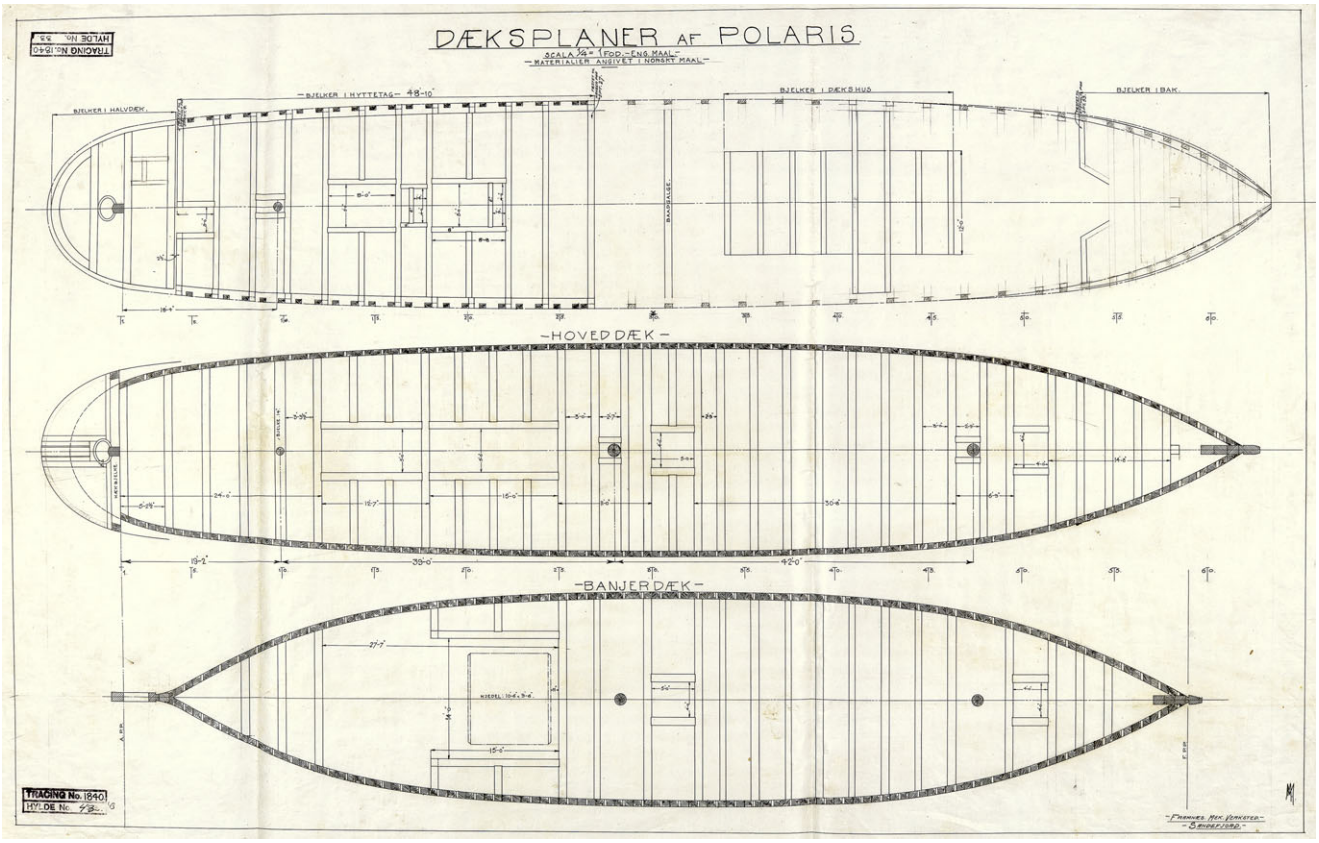
Figure 3. Decks of *Endurance*. From the top: bridge deck, main deck, and lower (tween) deck (Framnæs Mekaniske Værksted, 1911). Reproduced by kind permission of the Vestfoldmuseene.

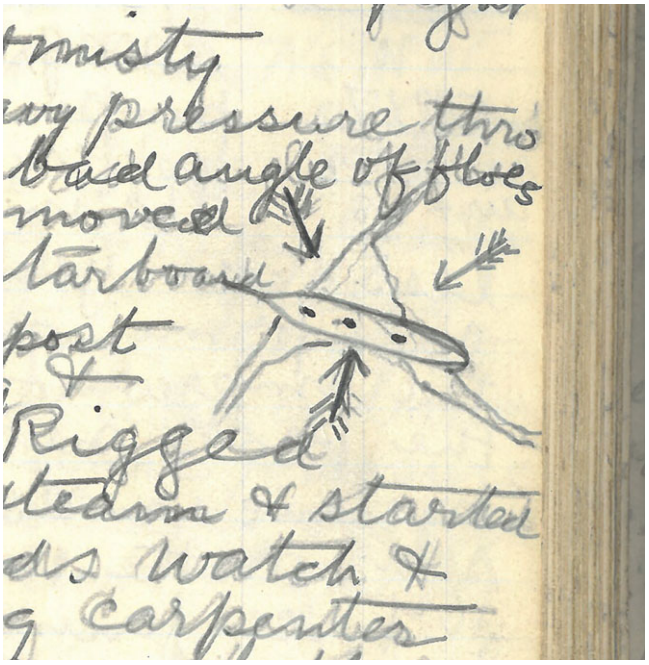
Figure 4. *Endurance* nipped by ice on 24 October 1915 (Worsley, 1916). Reproduced by kind permission of the University of Cambridge, Scott Polar Research Institute.

Worsley's diary from that day has a drawing of *Endurance* nipped by three ice floes, with arrows showing the motion of the ice. The drawing illustrates how the bow is held by one floe, another floe is loading the stern from the starboard side, while a third floe on the port side is loading *Endurance* at midships (Fig. 4). A drawing of the same event in Shackleton's book *South* (1920, p. 72) is similar, but a mirror image, with the stern loaded by an ice floe from the port side. The underwater images of the wreck of *Endurance* show the rudder at the sea bottom on the port side of the ship (Morelle & Francis, 2024; Addley, 2024), suggesting that the drawing in Worsley's diary is correct.

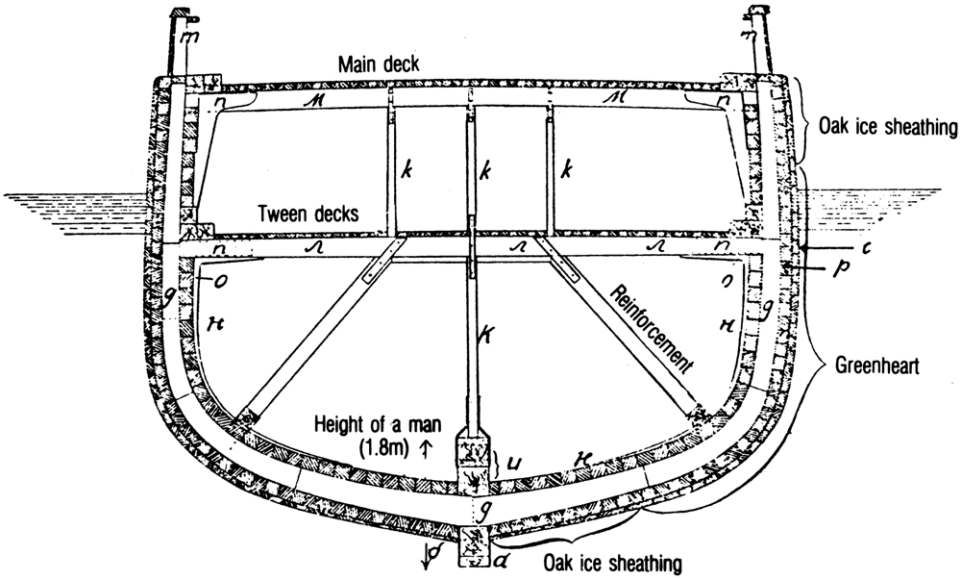
Shackleton helped Filchner in his preparations for the expedition (Mill, 1923, p. 185). In early 1911, Shackleton visited Sandefjord while *Deutschland* was there and advised Filchner to strengthen the ship's hull for the Weddell Sea ice by adding diagonal beams to the ship (Filchner, 1922, p. 26). Filchner followed that advice; the modified hull structure of *Deutschland* is shown in Figure 5.

Figure 5. *Deutschland*. Midship cross-section after modifications suggested by Shackleton (Filchner, 1922/1994). Reproduced by kind permission of the Erskine Press.

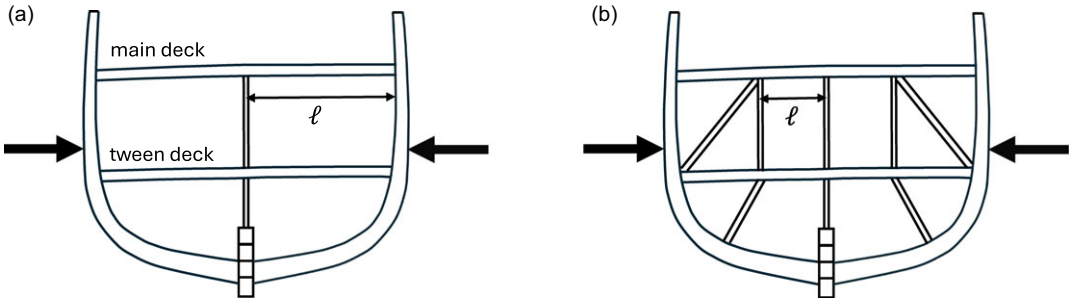
Scotia, Discovery, and *Endurance* were of the design shown in Figure 6(a), and the dimensions of their deck beams are compared in Table 2. The midship cross-sections of these ships show one stanchion at midships and thus $\ell \approx B/2$, where B is the ship breadth. In addition to their dimensions, the number of the deck beams also matters. Table 2 shows the number of beams per metre (N/L). By using $N/L \times bh^3/\ell^2$ as a proxy for the compressive load a ship can sustain, it can be calculated that *Scotia* carried about 2.7 times higher load than *Endurance*. *Discovery*, with higher ℓ, was about 10% weaker than *Endurance* in this respect. The midship

Figure 6. Idealised cross-sections of early Antarctic ships. Thick arrows represent compressive ice load. *Endurance*, *Discovery, Belgica, Scotia,* and presumably *Aurora*, were of the type (a); *Fram*, *Gauss* and *Deutschland* were of the type (b).

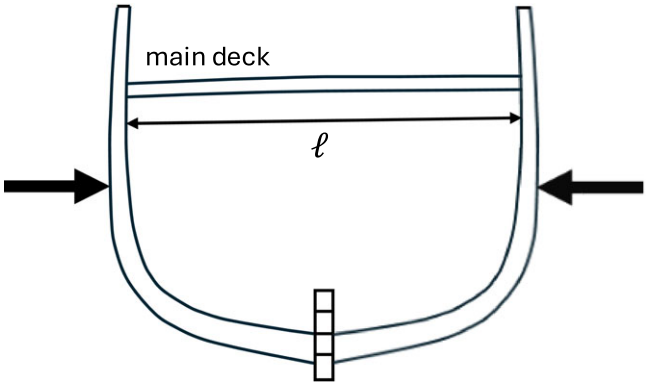
Due to the size of the engine and the boiler, many early polar ships, *Endurance* included, lacked a tween deck in the engine room. This created a large open space which, in the longitudinal direction, was defined by a bulkhead in front of the engine room and another behind it. In the vertical direction, the open space was defined by the main deck and the keel. From a structural point of view, the missing tween deck is a challenge, as illustrated in Figure 7. First, with the tween deck missing, all the compressive loading is carried by the main deck, and the strength of the hull is reduced by roughly half. Second, it is difficult to arrange stanchions in an engine room. This increases the span of the deck beams, and thus decreases their strength. Third, the frames lack all the support in the area limited by the main deck and the keel in the vertical direction. The larger the open engine room is, the weaker a ship is.

Figure 7. Idealised ship cross-section from a machine room area. Note the lacking tween deck. Compared with the cross-sections illustrated in Figure 6, both the deck span and the frame spans have increased.
