MRS Communications

Research Letter

Assessing failure in epitaxially encapsulated micro-scale sensors using micro and nano x-ray computed tomography

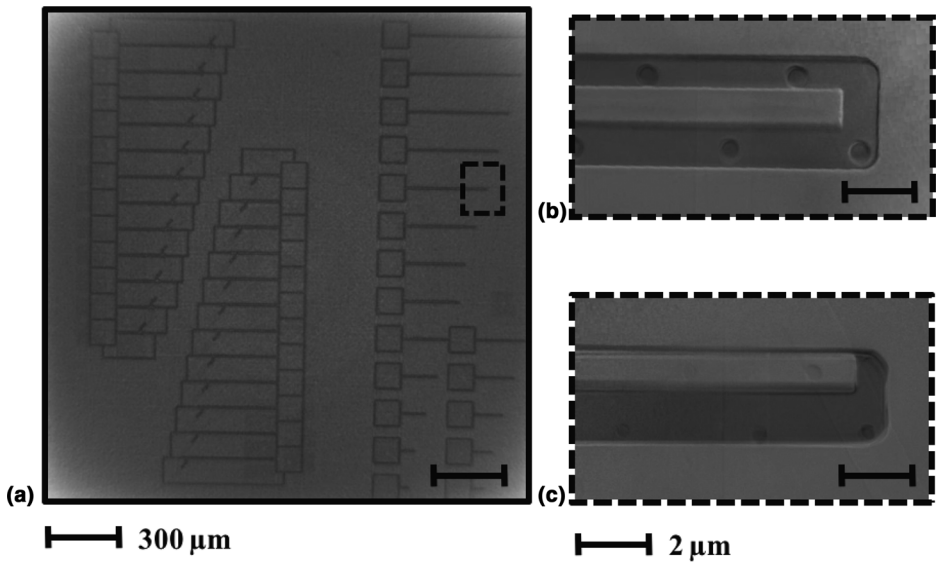
Figure 3. Results of micro- and nano-scale XCT of cantilevers: (a) micro-scale XCT image of the device layer of a die with cantilevers, the resolution is inadequate to discern whether stiction occurred, (b) nano-scale XCT of an oxide-coated polysilicon tip of a cantilever, (c) nano-scale XCT of single-crystal silicon tip of a cantilever.

We find that nano-scale XCT is useful to inspect the device features and determine if stiction has occurred. Figure 3 shows a cantilever fabricated with an oxide-coated polysilicon device layer (rough walls) and a cantilever fabricated with a single-crystal silicon device layer (smooth walls). The cantilever with rough walls showed no in-process stiction, while the one with smooth walls was stuck to the side wall. These results complemented previous studies that measured electrical shorts in such devices and proved that the incidences of stiction were higher in devices with smooth walls. By comparing cantilevers with different surface roughness and examining for stiction, this study allowed us to further characterize the effects of material roughness in the device layer of vacuum-sealed devices in preventing in-process stiction.

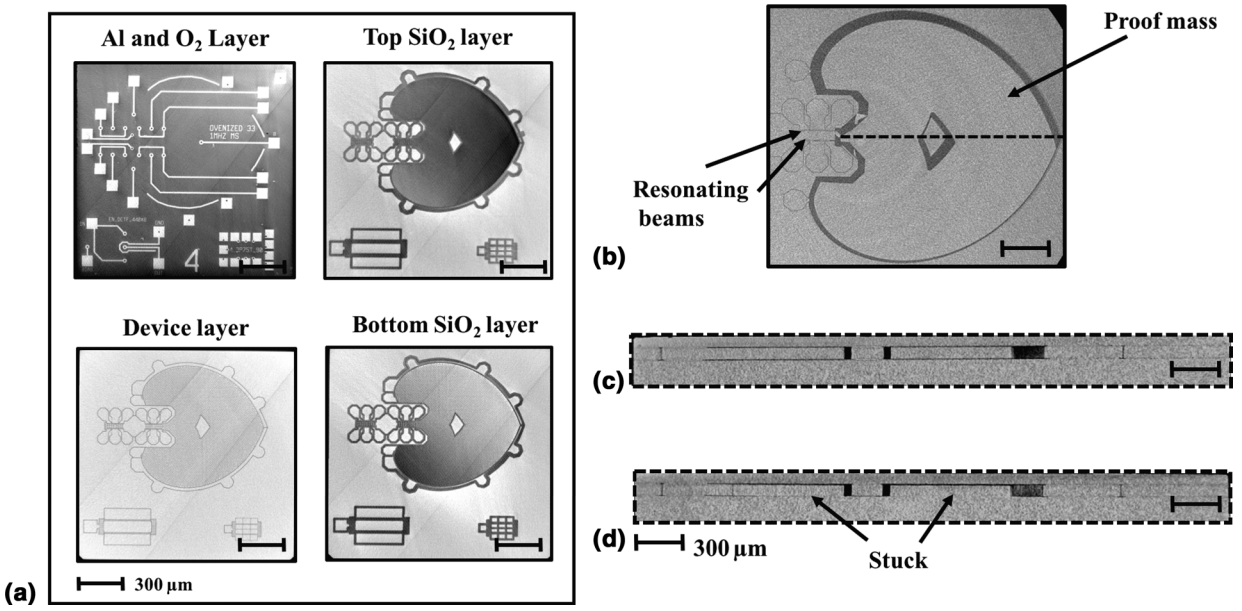
Figure 4(a) shows micro-XCT images of each layer of the die of a resonant accelerometer. By analyzing each layer through cross-sections of the three-dimensional reconstruction, we find that micro-XCT is effective at assessing for stiction failure in resonant accelerometers. Figures 4(b)–4(d) show

Figure 4. Micro-scale XCT images of a resonant accelerometer: (a) top view of each fabrication layer for the device, (b) top view of the device layer shows the proof mass stuck to the side wall, (c) cross-section view of a resonant accelerometer with no stiction, (d) cross-section view of resonant accelerometer shows proof mass stuck to bottom wall.

micro-XCT images of resonant accelerometers with both vertical and horizontal stiction. Prior to these results, the failure mechanisms for these devices were unknown; some of them were electrically shorted, but it was unclear where they failed. These images allowed us to identify where the devices were stuck and to consider at which step they failed. We could compare with simulations, confirm assumptions of failure mechanisms, and inform the next design iterations. This study demonstrated that the accelerometer mass had adhered to the substrate [shown in Fig. 4(d)] during a fabrication step prior to the cavity seal.

We find that micro-XCT is useful to inspect devices with fracture failure. Figure 4(b) shows a micro-XCT image of the top view of the resonant accelerometer; the beam that connects the accelerometer to the anchor is fractured. Prior to these results, the assumption was that the device had suffered from fatal stiction to the bottom surface. However, our results showed that the device had suffered from both stiction and fracture. The results allowed us to identify sections prone to fracture. As this mechanism is often accompanied by stiction, it is particularly hard to identify without destructively accessing the cavity.

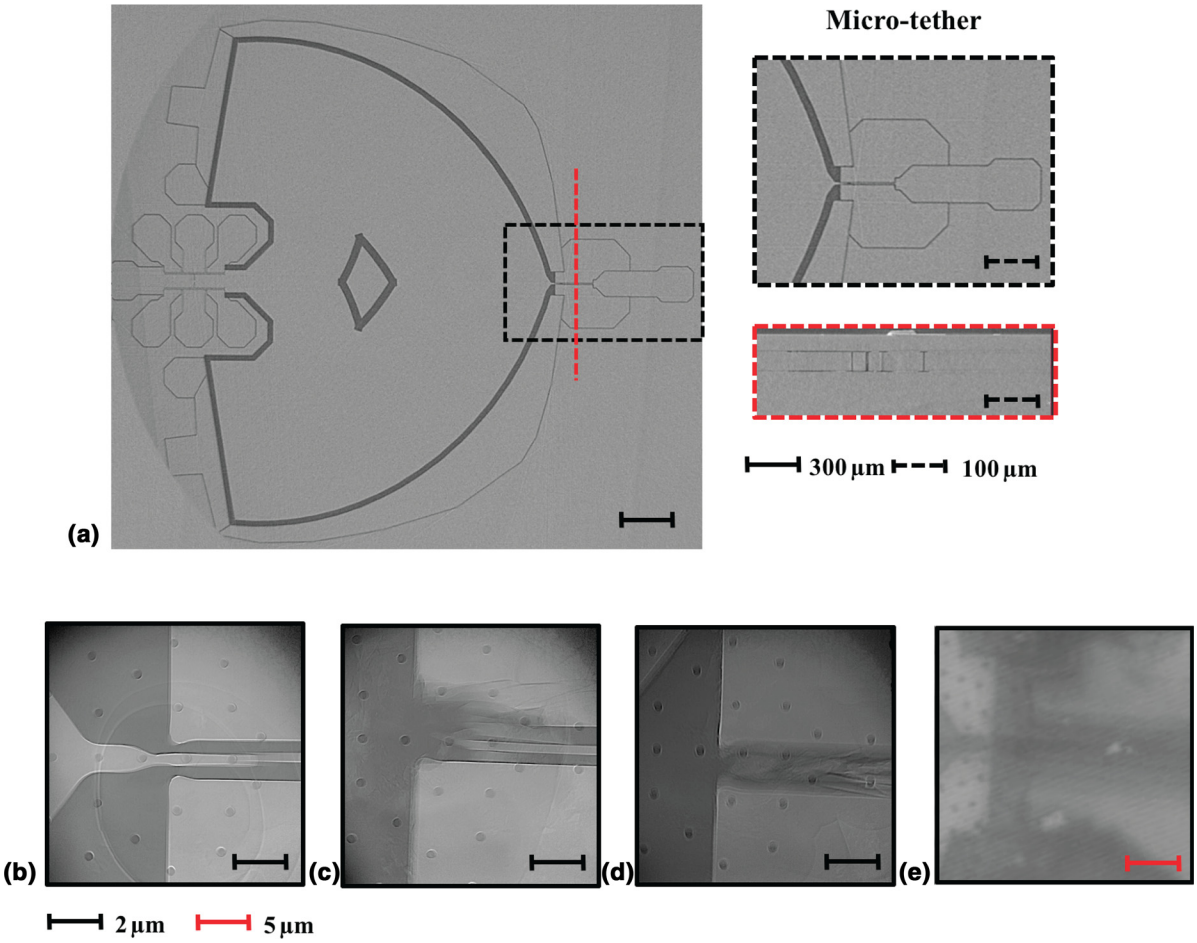
In testing a further iteration with a micro-tether to mitigate in-process stiction, we find that the resolution of micro-scale XCT is insufficient to discern the condition of the micro-tether after breaking, as shown in Fig. 5(a). The results show that nano-scale XCT is effective to discern the difference between breaking the micro-tether using Joule heating or high stress, as shown in Figs. 5(b)–5(E). In these images, we can distinguish that the micro-tether broken during the fabrication process has other impacted surrounding surfaces, shown in Fig. 5(c); similarly, the micro-tether broken with Joule heating melted the surfaces surrounding the micro-tether, as shown in Fig. 5(d). In summary, these results help us realize that the cleanest way of breaking the micro-tether was by applying a high stress, since the surrounding surfaces were unaffected, as shown in Fig. 5(b).

Figure 5. Results of XCT images of resonant accelerometer with tether: (a) top view of micro-scale XCT with zoomed view of tether area and cross-section, (b) broken tether after high-stress test, (c) broken tether in fabrication process, (d) broken tether with Joule heating, (e) IR image of broken tether with joule heating shows insufficient resolution to discern tether.

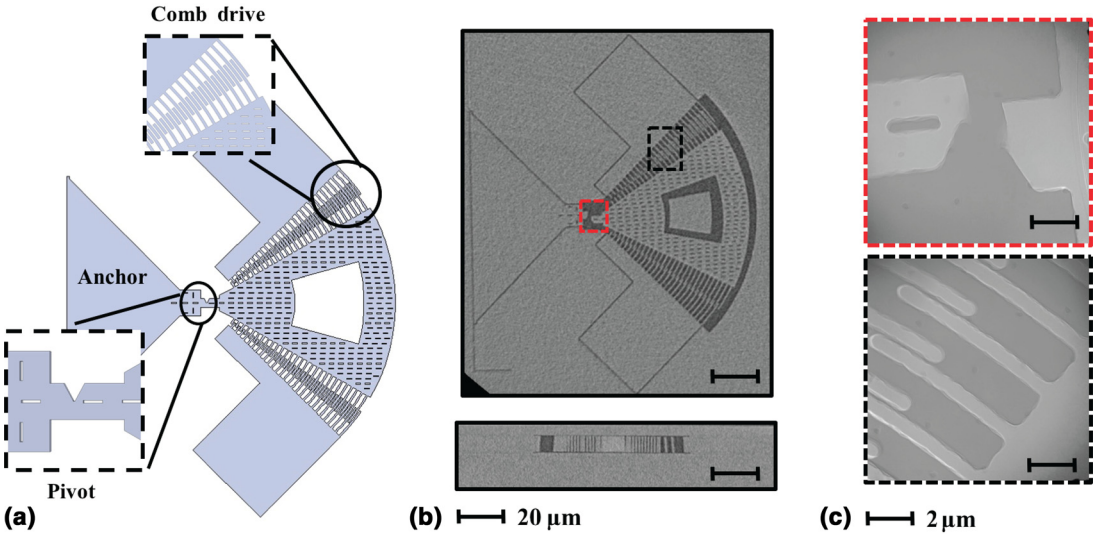
We find that nano-XCT is effective to examine the notch tip where the devices fail due to fatigue, and micro-XCT is useful to evaluate the condition of the entire structure after failure. Figure 6(b) shows a micro-XCT image of a fatigue device after failure; in this image, we can discern that the proof mass has rotated to the left after failure. Figure 6(c) shows a nano-XCT image of the notch, designed to crack following the material crystal orientation after fatigue failure, and the comb drive fingers stuck together after the proof mass rotated. The surface roughness of the epi-polysilicon device layer is also noticeable in these images.

This is the first time we could inspect vacuum-encapsulated devices after fatigue failure without destroying the sealed cavity. These results allowed us to affirm that these structures failed due to cracking and fracture and not due to other mechanisms such as electrical pull-in or stiction. We were also able to compare devices after failure and to complement past results that showed two very similar resonators with different fatigue responses. These results assisted in

Figure 6. Results of XCT for a fatigue test structure: (a) schematic representation of fatigue test structure, (b) micro-XCT images of device layer of a polysilicon oxide-coated device after failure and cross-section of comb drive section, (c) nano-XCT images of pivot and comb drive areas for one sample.
